Manhole Inspection Summary

Manhole # S65O__017MH

Insp Date: **5/12/08 3:15 PM**

Location Address: **1320 Broening Hwy.**

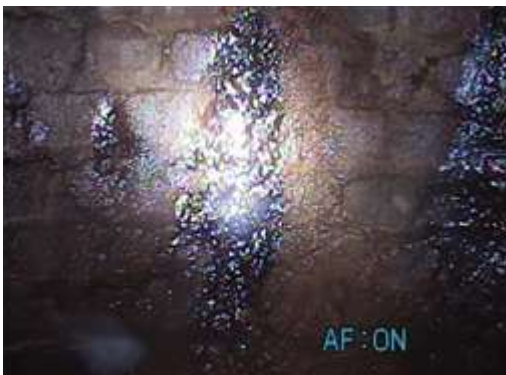
Defect 4

Infiltration: ☐ None ☐ Joint ☐ Cracks ☒ **Mortar** ☐ Roots ☐ Wall

Infiltration in barrel wall

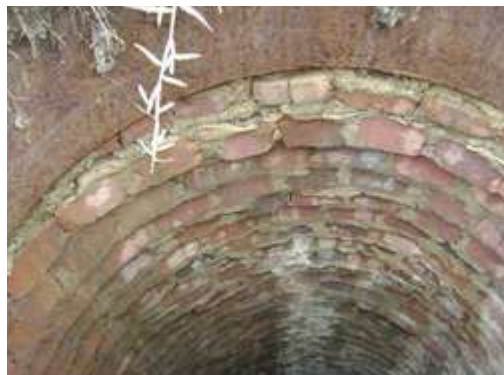
Defect 1

Condition: ☐ Sound ☐ Cracked ☐ Root Intrusion ☒ **Loose Brick** ☒ **Deteriorated**

loose and cracked bricks at frame adjustment.

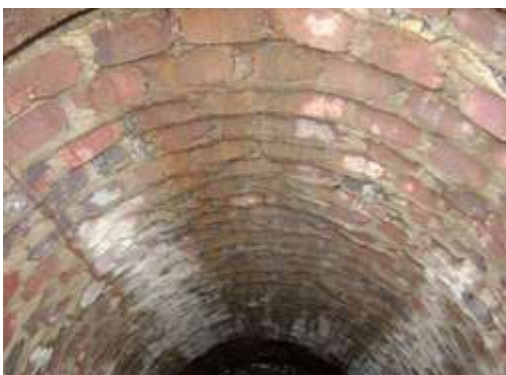
Defect 3

Infiltration evidence

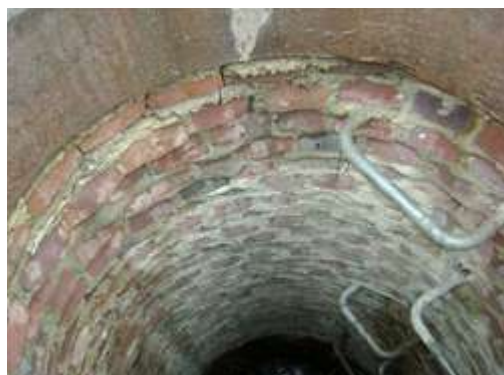
Defect 2

Deterioration of the frame adjustment.

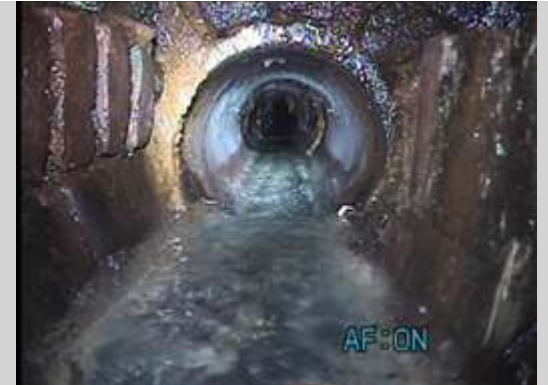
12 O'Clock Outflow

8 in. Circular Gravity Sewer
Pipe Out @ 12 O'Clock

Pipe Height: **8.4** (in.) Rod and Bar (Angled)
Pipe Material: **Clay** ☐ Pipe Lined
Invert Depth: **12.67** (ft.) Flow Characteristics: **Slow**
Deposits: ☐ None ☐ Mud ☐ Gravy ☐ Debris ☒ Grease
Silt Depth: **0.125** (in.) Deposits Extent: **Light**
Infiltration: **None** Pipe Seal Cond: **Sound**

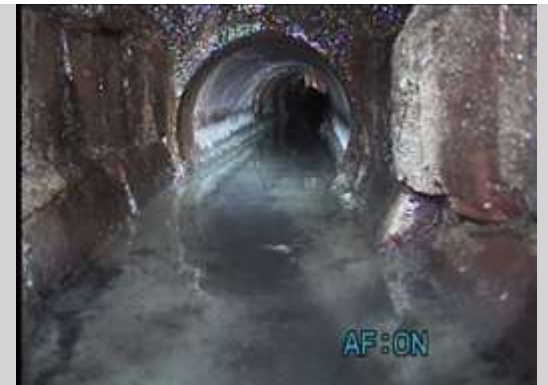
6 O'Clock Inflow

8 in. Circular Gravity Sewer
Pipe In @ 6 O'Clock

Pipe Height: **8.4** (in.) Rod and Bar (Angled)
Pipe Material: **Clay** ☐ Pipe Lined
Invert Depth: **12.58** (ft.) Flow Characteristics: **Slow**
Deposits: ☐ None ☐ Mud ☒ Gravy ☐ Debris ☒ Grease
Silt Depth: **0.25** (in.) Deposits Extent: **Light**
Infiltration: **None** Pipe Seal Cond: **Sound**
